**Evaluation of mechanical soft-abrasive blasting and  
chemical cleaning methods on alkyd-paint graffiti made on  
carbonate stones**

Dissertação para obtenção do Grau de Mestre em  
Conservação e Restauro

FACULDADE DE  
CIÊNCIAS E TECNOLOGIA  
UNIVERSIDADE NOVA DE LISBOA

**Janeiro 2015**

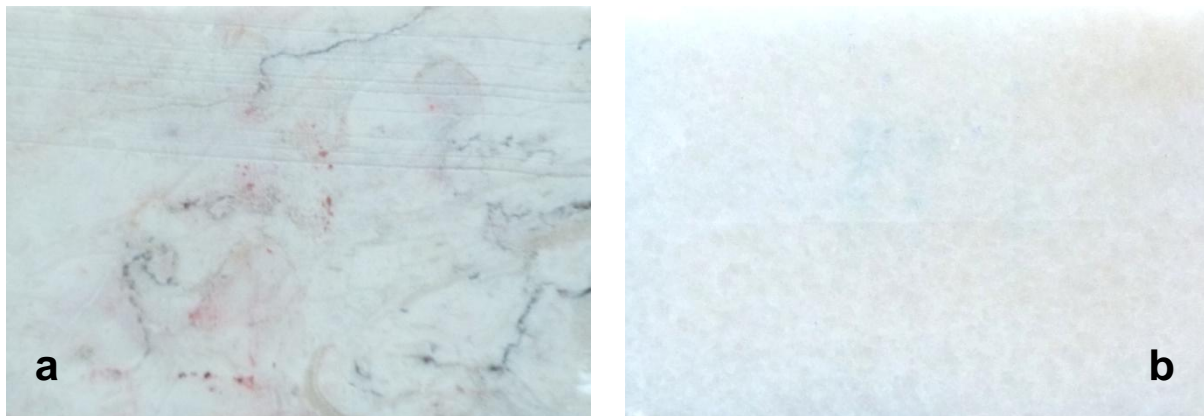
Figure 2.1. - Investigated lithotypes: a) Lioz; b) Branco stones

*Lioz* is a coarse cream microcrystalline limestone, bioclastic and calciclastic, whereas *Branco* is crystalline calcite marble (~98% calcite), with a granoblastic texture with medium-grained zones. A detailed petrographical, chemical, physical and mechanical characterization of this limestone and marble is presented by [43] and [44], respectively. In spite of their different geological and petrographical characteristics, both lithotypes present very low porosity (<0.40%) and water absorption capacity (<0.15%) [45] their uniaxial compressive and flexural strength can be considered medium to high (>1000 kg.cm<sup>-2</sup> and >200 kg.cm<sup>-2</sup>, respectively) [45].

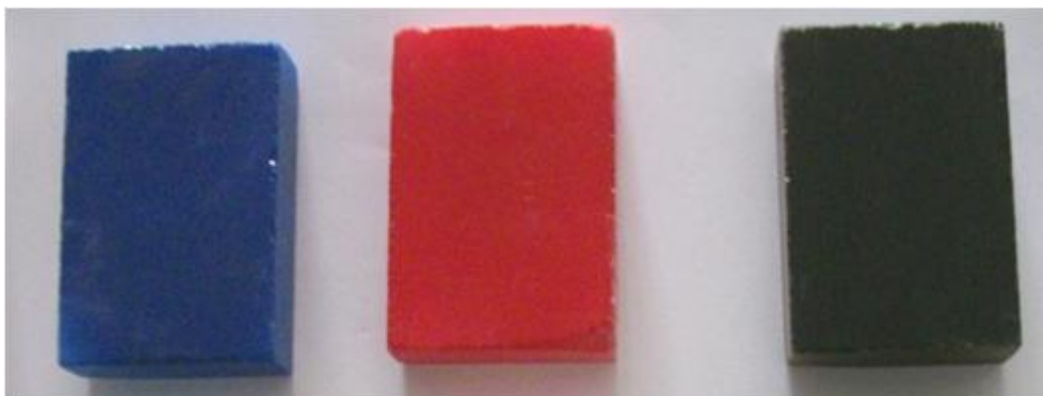
Figure 2.2. - Investigated lithotypes and alkyd sprays applied: jet black, carmine red and gentian blue paints.

The alkyd spray paints used in this work (Fig. 2.2.) correspond to trademarks MOTIP HOME & HOBBYLACQUER® [46]. The colours selected were gentian blue (RAL code R-5010), carmine red (R-3002) and jet black (R-9005). These sprays were chosen based on their low price and availability in non-specialized stores and their probable different interactions with stone substrata due to the use of different pigments, dyes or fillers. Details of the particular paint formulations are proprietary of the manufacturer and not available.
